**Bridlemile Elementary
Safe Routes to School Problem and Solutions Summary
May 2006**

Introduction

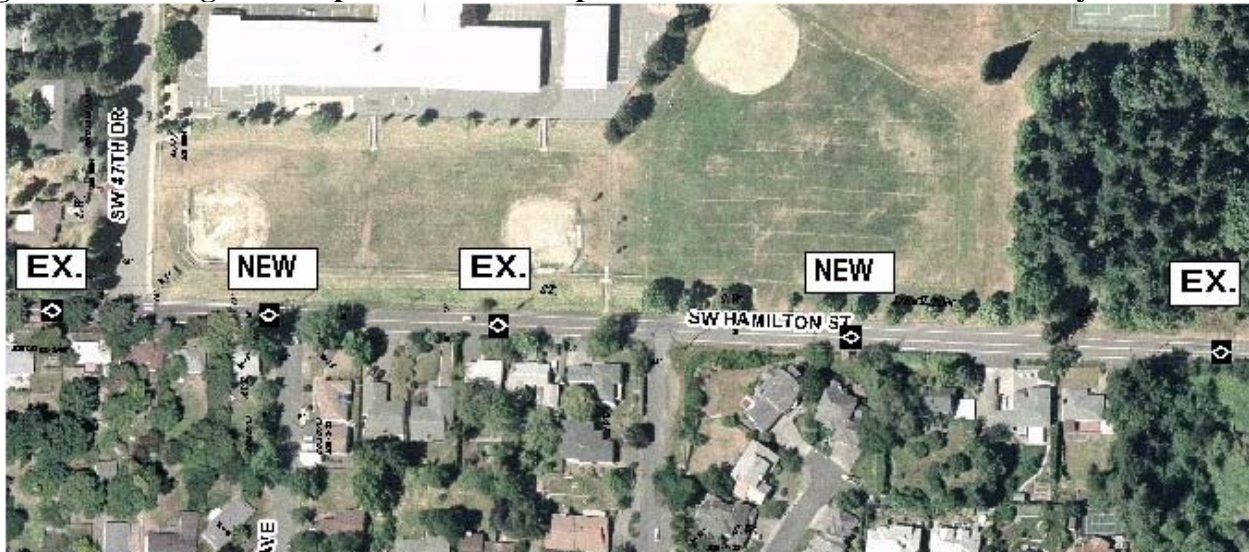
Figure 2. Existing and Proposed Hamilton Speed Tables at Bridlemile Elementary

It is recommended that an alteration of the speed table layout on SW Hamilton be undertaken to further reduce speeding there. The speed tables on either side of SW 47th Drive are approximately 560 feet apart while the tables on either side of 45th Avenue are over 860 feet apart. For a posted speed of 30 mph the recommended spacing is 500 to 600 feet. To achieve average speeds closer to the posted 20-mph school zone speed, the 22-foot speed tables should not be placed farther than 400 feet apart. 22-foot speed tables are necessary on SW Hamilton (instead of the shorter 14-foot bumps) due to the transit designation of the street. Two additional speed tables are recommended between the existing three placed from west of 47th Drive to just west of 41st Avenue. This change is estimated to cost \$4,000 and will require an open house, though it may not require approval of adjacent property owners. This change will also make the crossing of Hamilton safer.

Further adjustments outside these boundaries is also recommended to bring the speed table layout up to current standards for the posted speed of the street. Hamilton east of 45th is scheduled for resurfacing in 2007 and this would present a good opportunity to revisit the table layout. Any existing speed tables would be reconstructed as part of normal maintenance activities, so the cost of the same number of tables would be borne by the City. Additional speed tables could be funded from the Bridlemile SR2S fund, however an additional public process would be needed to approve a new speed table layout.

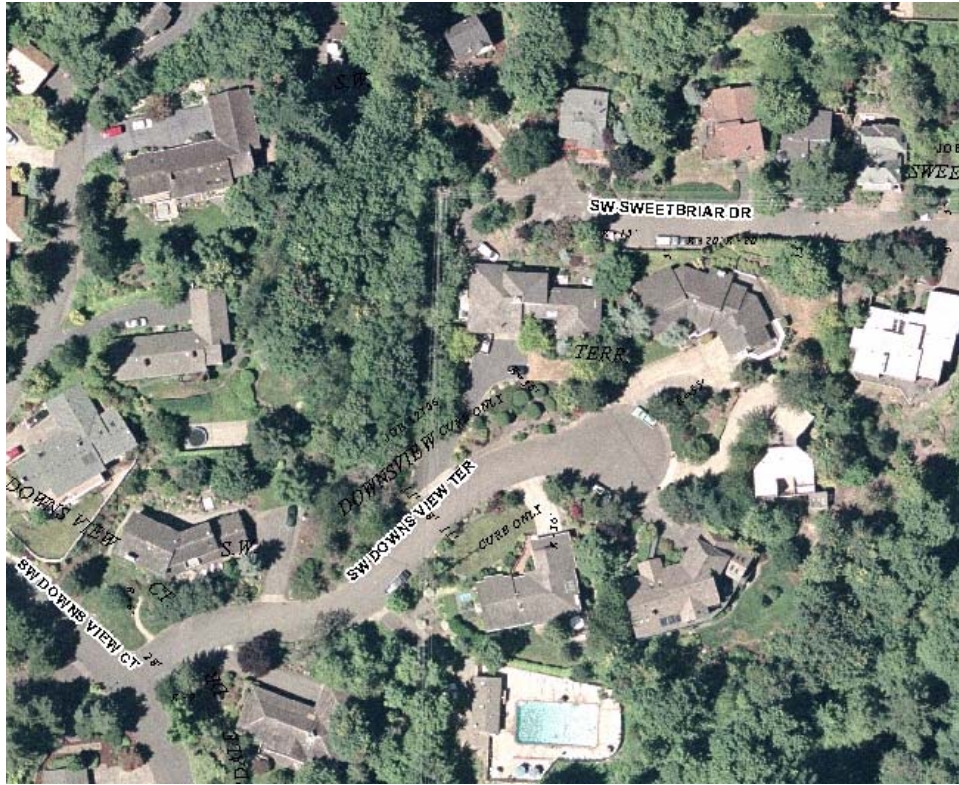
Figure 14. Downsview at Sweetbriar

There is currently no trail connecting Downsview to Sweetbriar (Figure 14). Land use planning to identify pedestrian needs is one long-term solution to achieve public right of way between the two streets. More expedient would be a public-private partnership to acquire an easement from adjacent property owners. From the photo, it appears a utility easement already exists. This may be a good location on which to piggyback a trail.

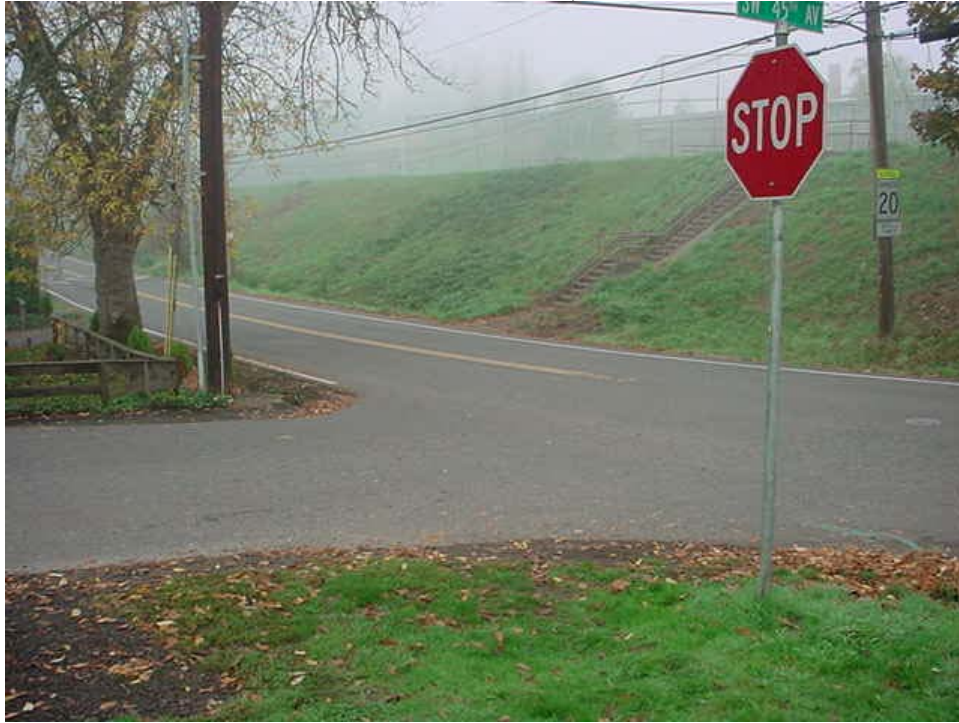
Figure 15. Hamilton Staircase as Seen from SE Corner, 45th and Hamilton

Several students cross Hamilton at SW 45th. The southeast corner of the intersection provides the most space for pedestrians to wait, but the preferred destination is northwest of the intersection where an existing staircase connects Hamilton to school grounds (Figure 15, next page).

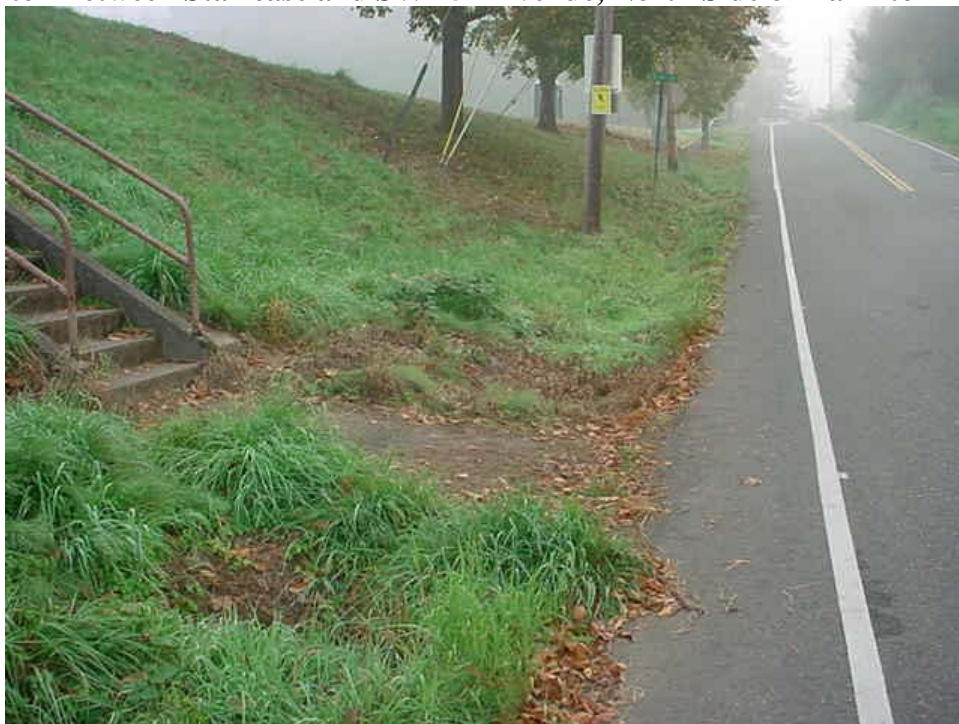
Figure 16. Ditch Between Staircase and SW 45th Avenue, North Side of Hamilton

Existing ditches along Hamilton make the path to the stairs difficult as shown in Figure 16, below.

The extension of the existing culvert at the staircase using 6-inch perforated PVC pipe and filling the ditch with crushed rock would provide two or three feet of added shoulder width on the north side of Hamilton as a pathway to the staircase. A similar treatment at the southeast corner of 45th and Hamilton would significantly improve the pedestrian waiting area (Figure 17, below). This would also make the corner ideal for relocating the eastbound Tri-Met stop currently at the southwest corner.
